Faysal A. Yafi, James Furr, Georgios Hatzichristodoulou, Luca Venturino, Robert Andrienne, Daniar Osmonov, David Ralph, Javier Romero Otero, Maxime Sempels, Koenraad van Renterghem, Steven K. Wilson

University of California Irvine; University of Oklahoma; Martha-Maria Hospital, University of Erlangen-Nuremberg; University College London Hospital; University Hospital of Liège; University Hospital Schleswig-Holstein; Hospital Universitario 12 de Octubre; Jessa Hospital; Institute for Urologic Excellence

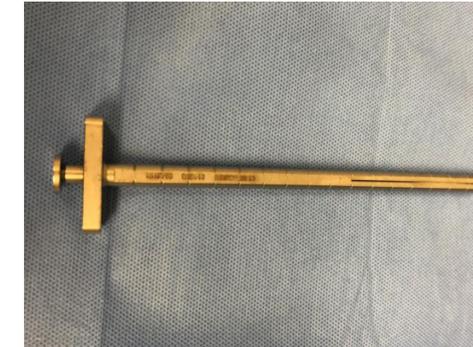
Furlow assembled

- We performed a prospective analysis of cultures of the Furlow Inserter used for PP surgeries from 7 centers between May 1st and June 30th, 2019.
- Once the Furlow was received for surgery, the surgical team inspected the device for assembly status (disassembled or not) and the presence of visible stains, pieces of tissue or discoloration on either the interior of the barrel or the plunger.
- Swab aerobic and anaerobic bacterial and fungal cultures were then obtained from the internal component, after removal from the external component if assembled, and after introduction and immediate removal from the external component if disassembled.

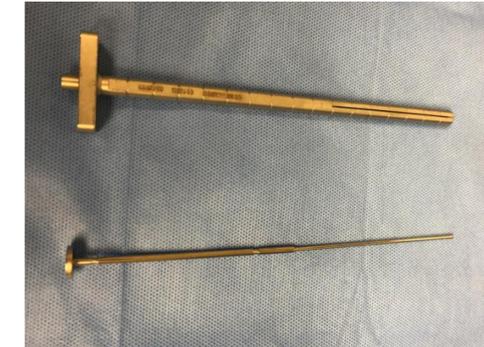
Furlow disassembled

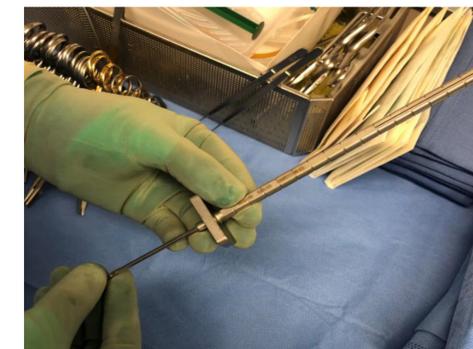
Internal component inserted then removed

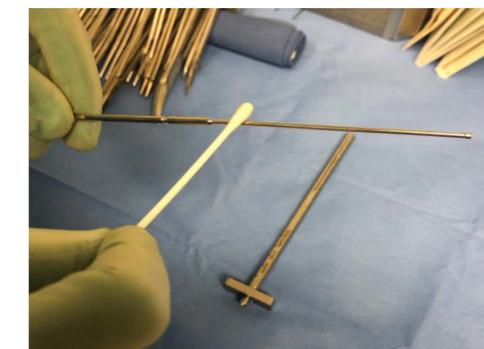
Culture swab of internal component
